Technical Note N-1044

PROTECTION OF FLOATING PONTOONS FROM CORROSION -- PART III.
CONDITION OF TEST FLOATS AFTER THREE YEARS

August 1969

↓
NAVAL CIVIL ENGINEERING LABORATORY
Port Hueneme, California 93041

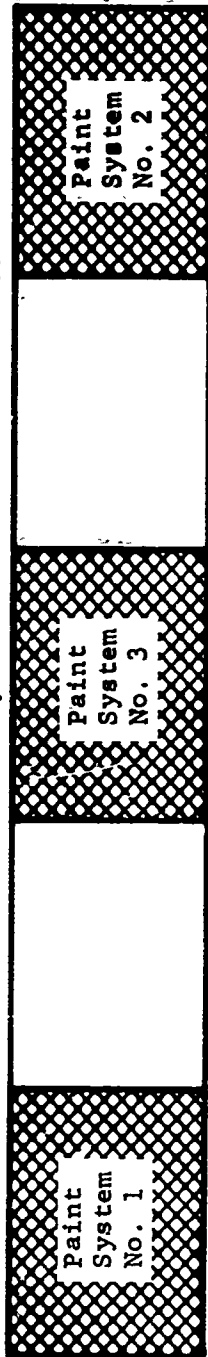
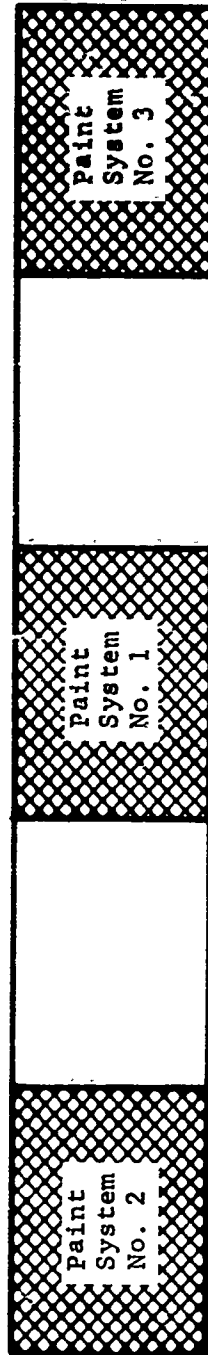
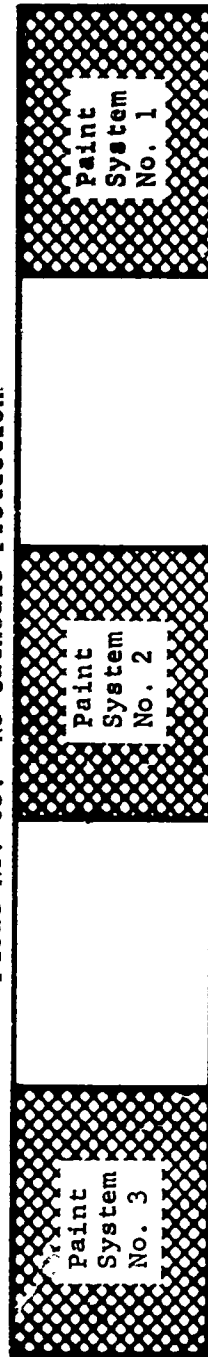
Figure 3. Design of pontoon float test.

Each test float consisted of three pontoons spaced a pontoon length apart and secured together with steel angle-iron bracing. They are commonly called 1 x 5's, because they have a width of one and a length of five pontoons. The test design for the three floats is shown in Figure 3. Each of three paint systems investigated was applied to one of the three pontoons in each test float. The pontoons in each float were arranged randomly as shown in Figure 3, so that each coating system would have the same magnitude of exposure to impact and abrasion damage. The design also permitted a study of the effect of each cathodic protection system on each of the three coating systems.

Float No. 01: Cathodically Protected With Zinc Anodes:

Float No. 02: Cathodically Protected With Aluminum Anodes:

Float No. 03: No Cathodic Protection.
